Inspection Report

Property Address:
333 Wild Raspberry Lane
Etowah NC

HomeBuyers Inspection HBI

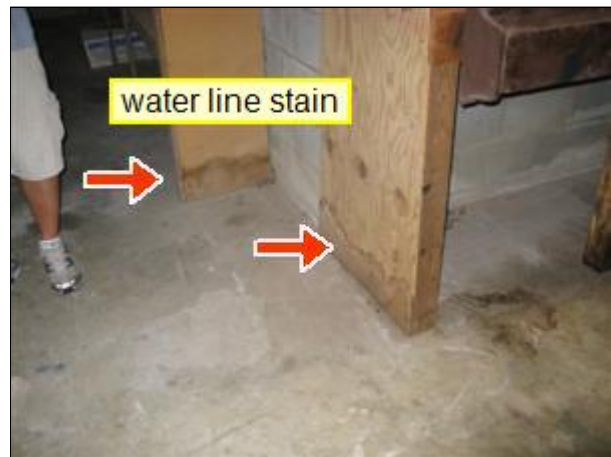
1.0 Picture 4

(2) Water signs on cedar wall and trim. Also a mold like substance on carpet at lower level and under stairs. I did not inspect or test for mold and I am unable to determine if water intrusion occurs.

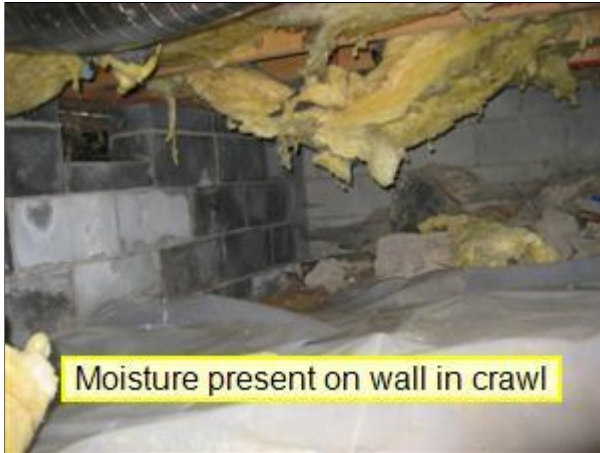
1.0 Picture 5 crawlspace under kitchen

🔍 (3) Visible signs of water intrusion in the crawspace (along front of home) are present from dampness along the block wall. I am unable to determine the extent of intrusion or how often it occurs. Cross ventilation may help as the crawls has no ventilation. I recommend further investigation or correction by a qualified licensed contractor or water infiltration specialist. Refer to the diagram as a guide if a drainage system is needed.

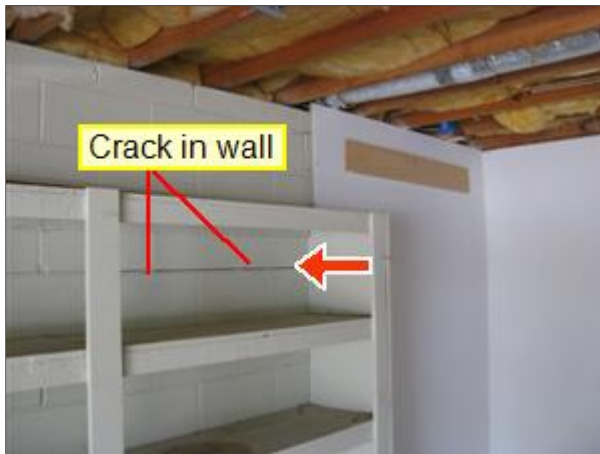
1.1 Picture 1

🔍 1.1 There is a horizontal crack(s) in the foundation wall at the left side (facing front). These cracks do not appear significant to require repairs at this time. This is my opinion and you should seek a second opinion by a qualified person.

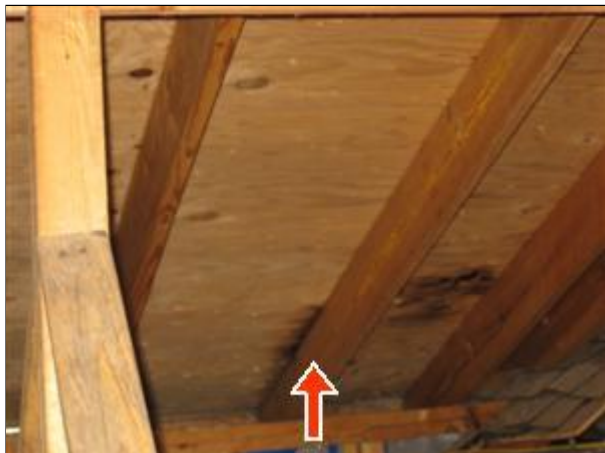
1.5 Picture 1

🔍 **1.5** Leak signs in attic perhaps or likely from the *old roof* as this newer roof appears in tact. I am unable to determine if leak exists due to no recent rain.

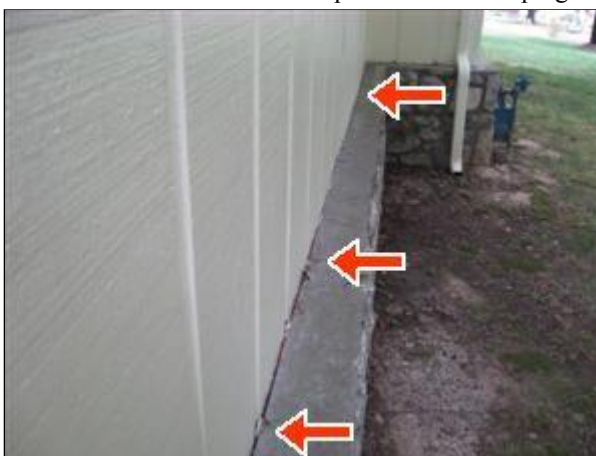
2.0 Picture 1

2.0 Periodical maintenance caulking needed and recommended to keep water from weeping under siding at concrete shelf. FYI

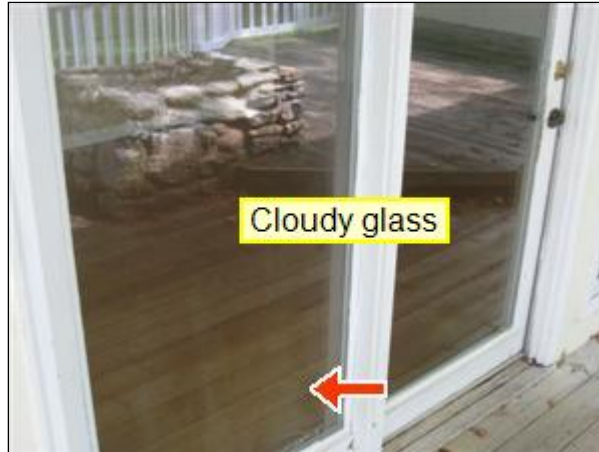
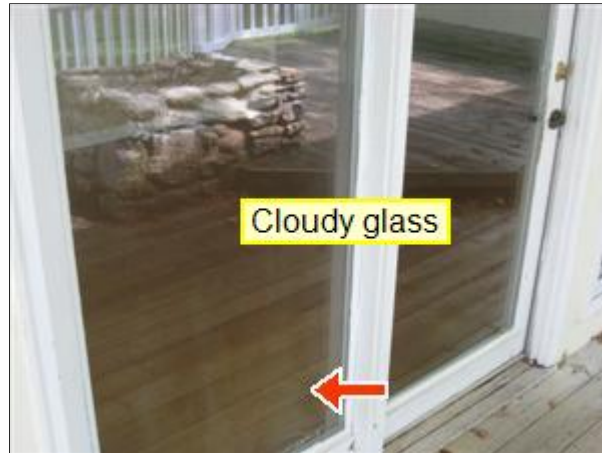
2.1 Picture 1

2.1 Patio doors at rear of home are cloudy or seal is broken. Glass panes that have lost their seal (cloudy) can usually be replaced without replacing the entire unit. A qualified contractor should inspect and repair as needed.

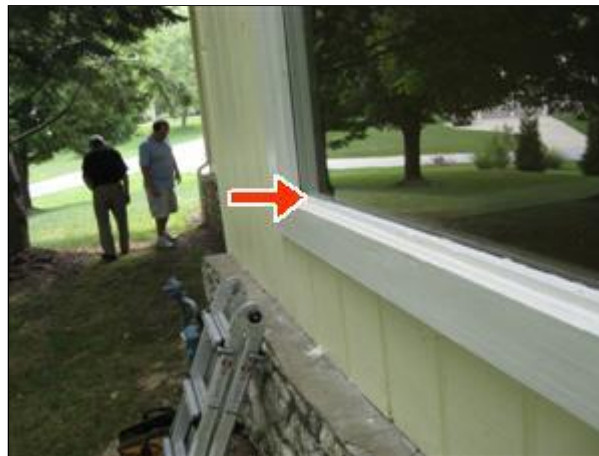
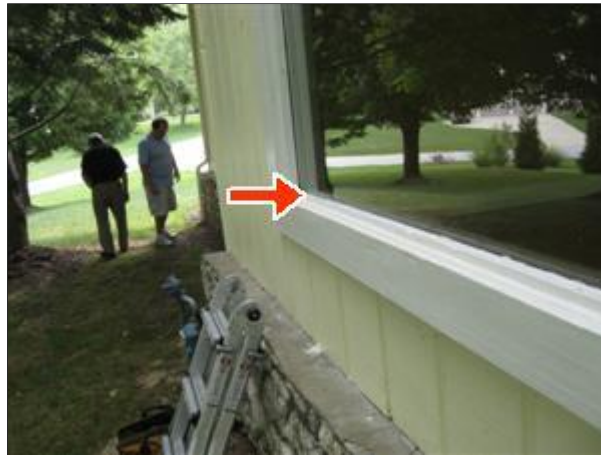
2.2 Picture 1

2.2 The trim stop for fixed pane is weathered and indicates that water may be getting below trim. I recommend a paintable sealant be applied and paint trim.

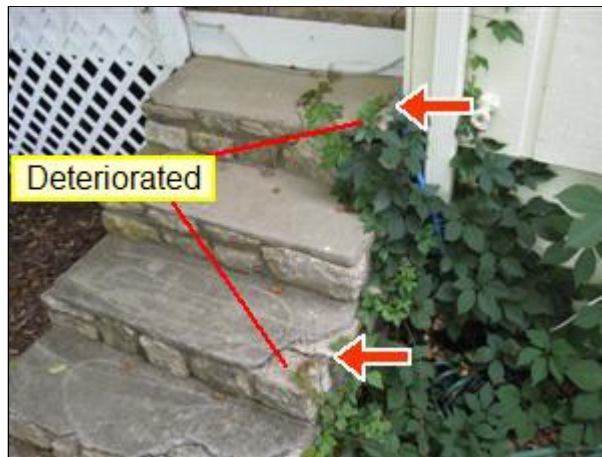
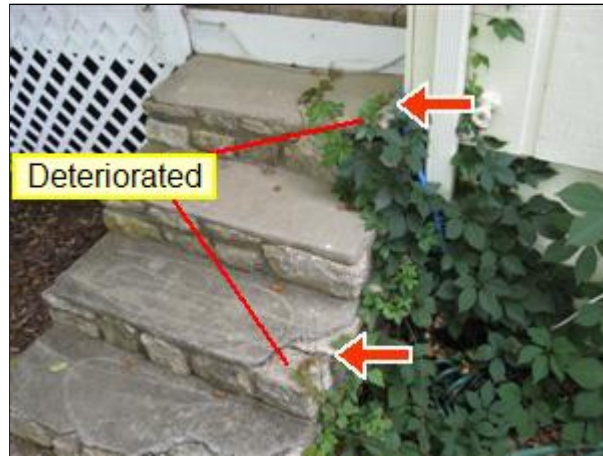
2.3 Picture 1

2.3 (1) The step tread on steps on the deck at the rear of home are deteriorated. A repair or replacement is needed. A skilled masonry contractor should perform the work.

A handrail may be needed

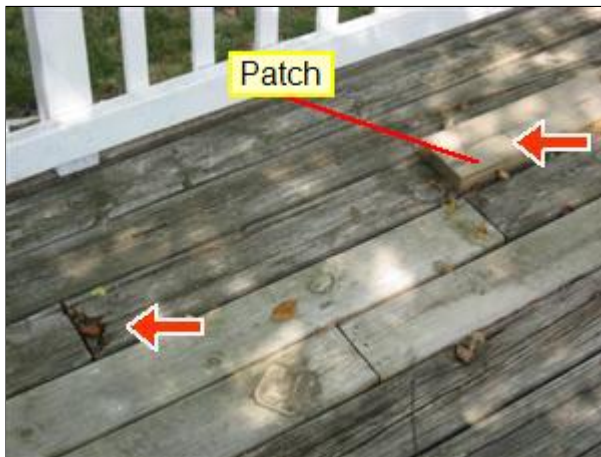
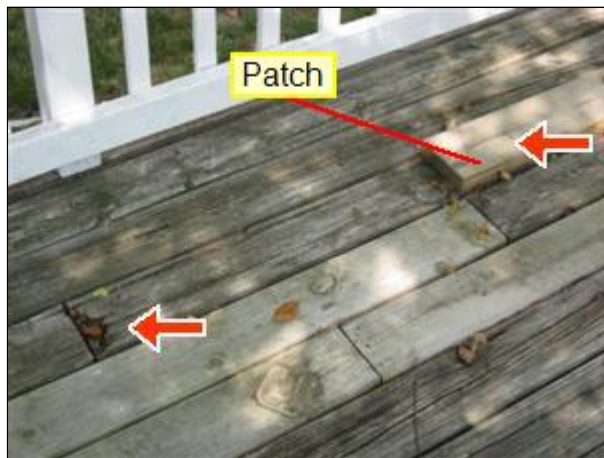
2.3 Picture 2

🔨 (2) The 2x6 decking on the deck at the rear of home has several boards that are deteriorated. A general replacement is likely. A qualified contractor should determine whether a repair or replacement is needed.

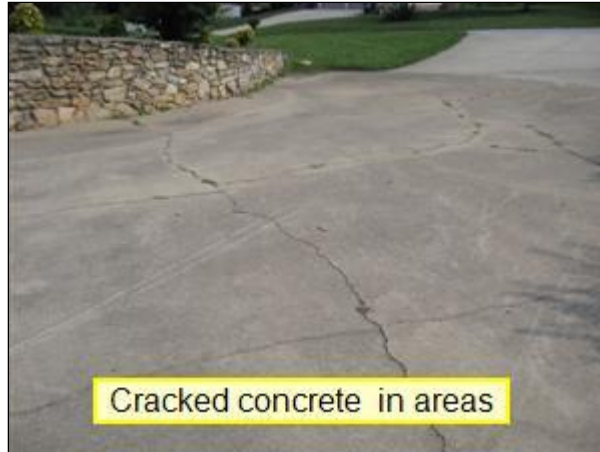
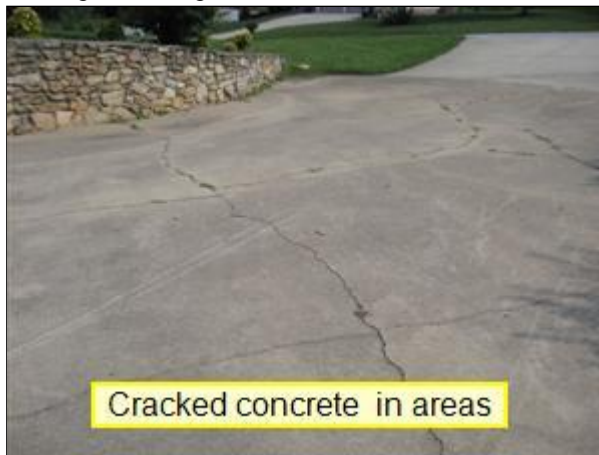
2.4 Picture 1

🔧 **2.4** The concrete drive at the front of home is pitted in areas and has settlement cracks. Further deterioration can occur if not repaired. A qualified contractor should inspect and repair as needed.

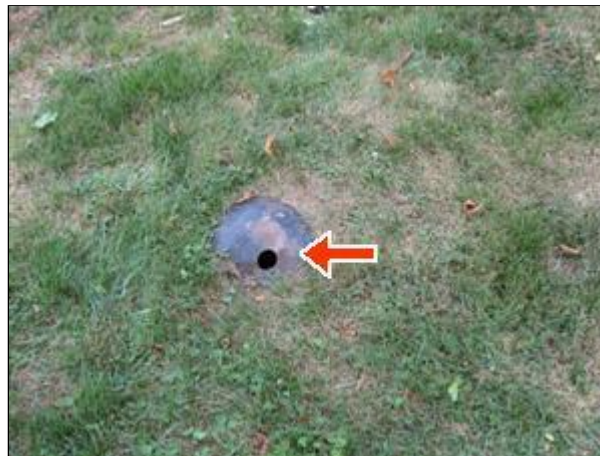
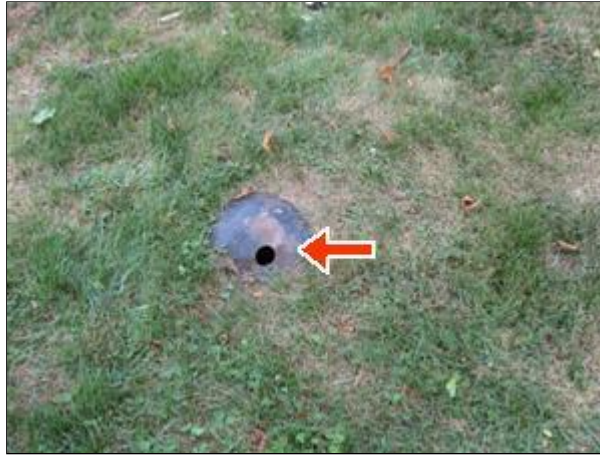
2.6 Picture 1

🔍 **2.6 (1)** Old propane tank in ground and is discontinued. I did not determine if gas remains in discontinued tank? I recommend further investigation by a qualified person.

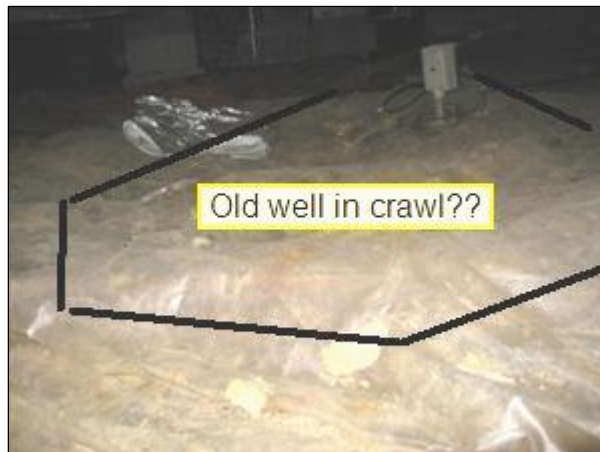
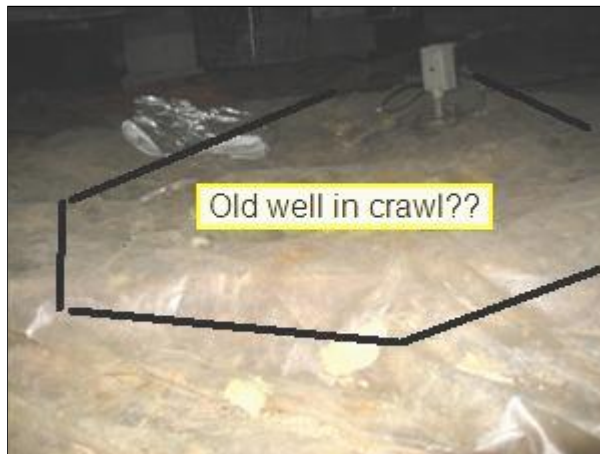
2.6 Picture 2 in crawlspace under new addition

🔍 (2) There is an odd configuration in ground under addition in crawlspace. This may be an old well? I am unable to determine. I recommend a qualified well drilling company or plumber investigate further to determine if any further action is needed to correct.

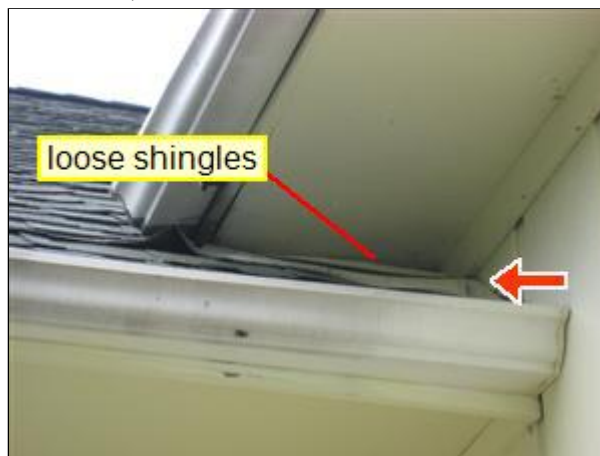
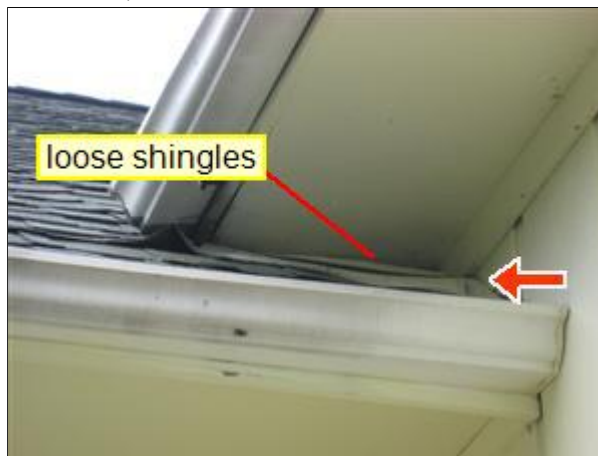
3.0 Picture 3

(2) Shingles loose under eave at front of home, needs adhesive.

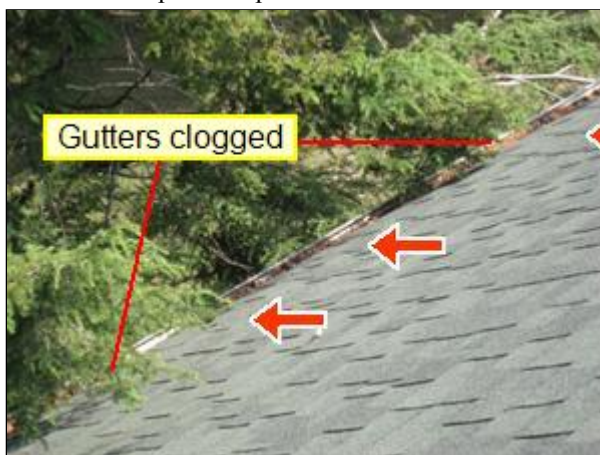
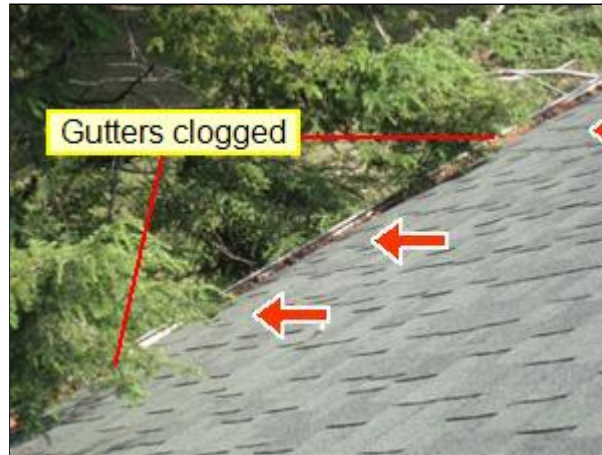
3.3 Picture 1

3.3 The gutter needs cleaning of debris at the virtually all areas where gutters are installed. Gutters that drain poorly or clogged can lead to many costly problems such as deterioration of fascia, soffit or roof edge. It can also cause gutters to pull loose and lead to possible water intrusion. A qualified person should repair or replace as needed.

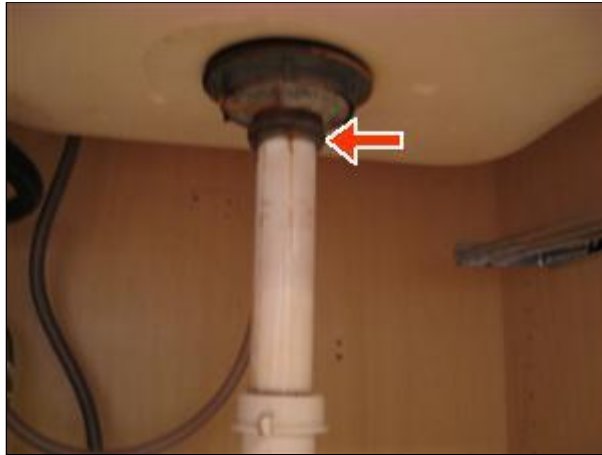
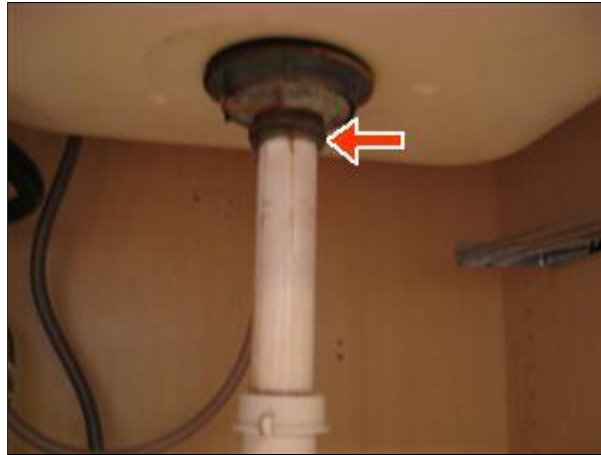
4.0 Picture 1 Right sink basin

**4.0 (1)** The basket strainer had leaked and corrected itself for the time being at the Kitchen sink. Repairs are needed. A qualified person should repair as necessary.

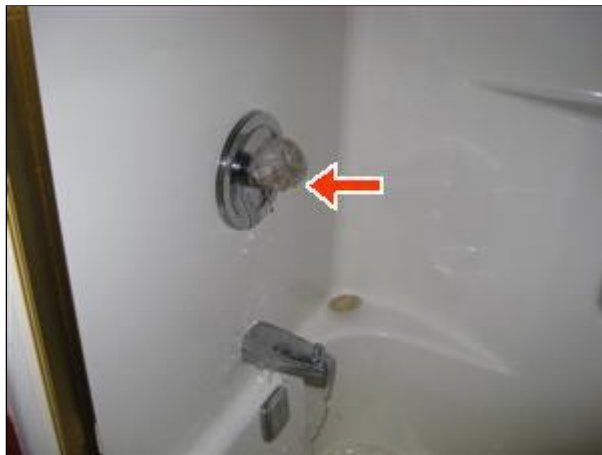
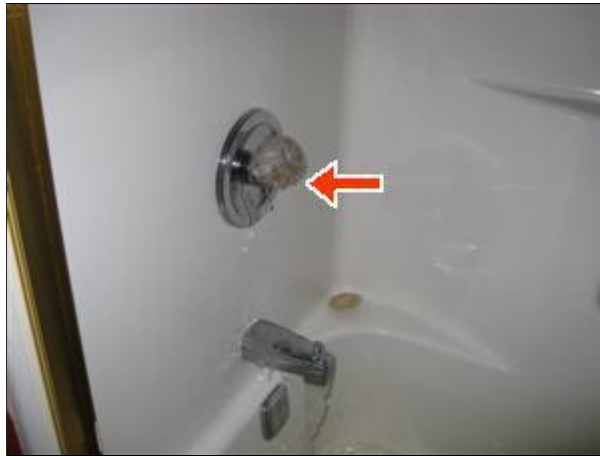
4.1 Picture 1 hall bath

🔧 4.1 (1) The control knob leaks at the hall bath. Repairs are needed. A qualified licensed plumber should repair or correct as needed.

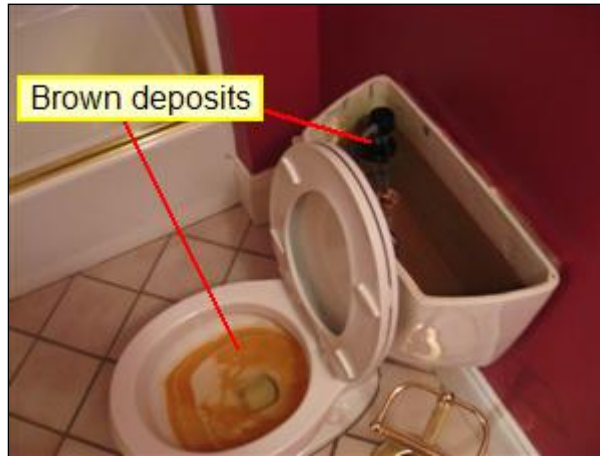
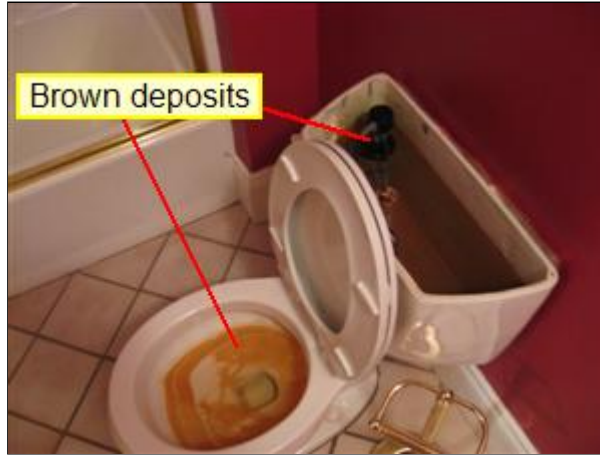
4.1 Picture 2

🔍 (2) Brown deposits are on the plumbing fixtures which indicates a filter may be needed. Filter in place and appears dirty but I am unable to determine if you need a different or additional filter. I did not test water for bacteria or other. I recommend contacting a water filtration company.

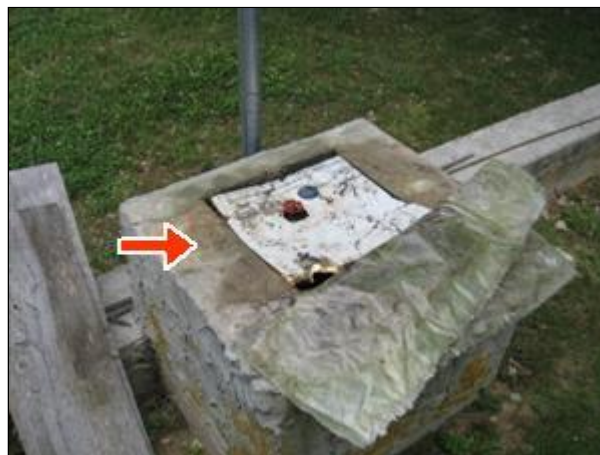
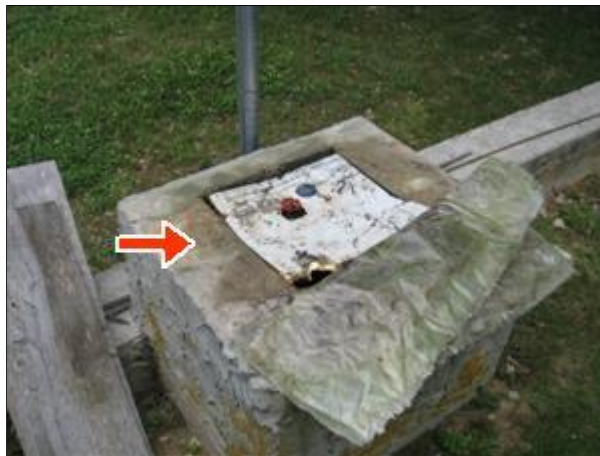
4.1 Picture 3 Well head

🔧 (3) I recommend the well head lid be insulated better before winter. FYI

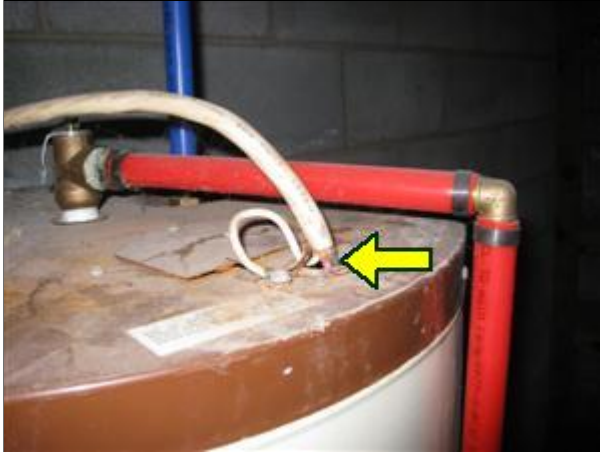
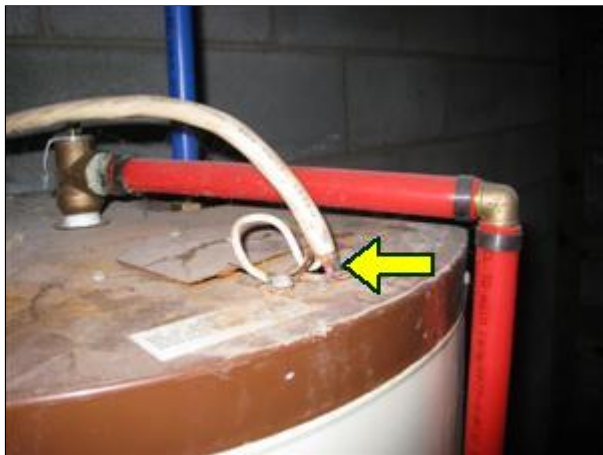
4.2 Picture 1

4.2 The wiring for the water heater missing romex connector. Electrical issues are considered a hazard until repaired. I recommend a licensed electrician correct as necessary.

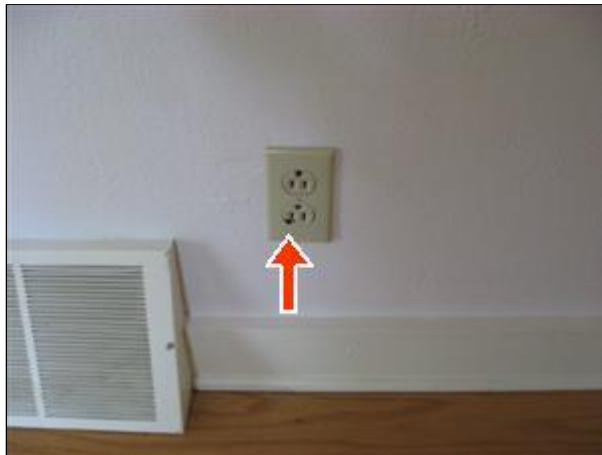
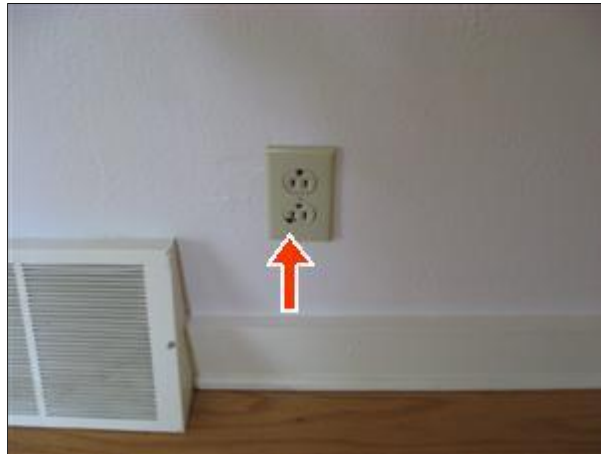
5.3 Picture 1

5.3 (1) The wall switch is broken (unsafe) at the upstairs closet for air handler. At least two outlets are broken at LR and entry way. Electrical issues are considered a hazard until repaired. A qualified licensed electrician should perform repairs that involve wiring.

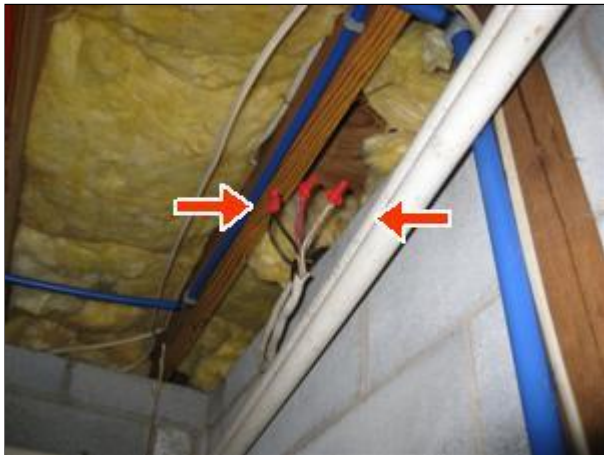
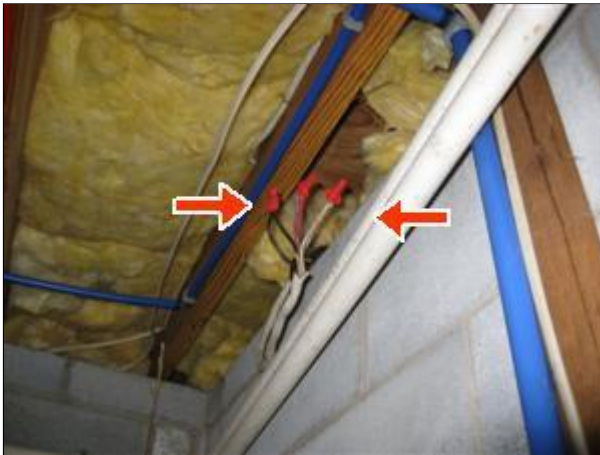
5.3 Picture 2

🔧 (2) Several loose wire ends needs placing inside a box with a cover-plate in the basement at the pressure tank of well. I recommend repair as needed.

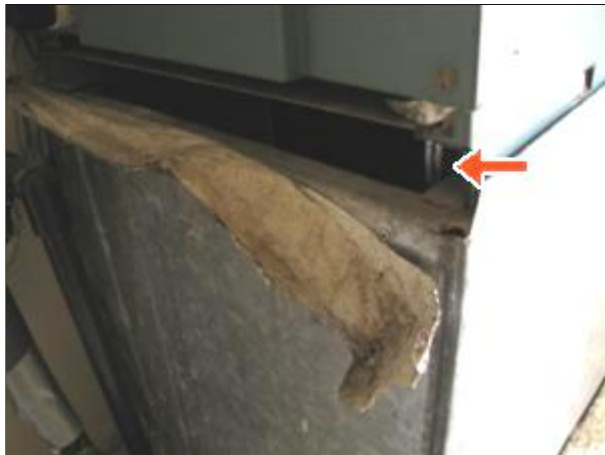
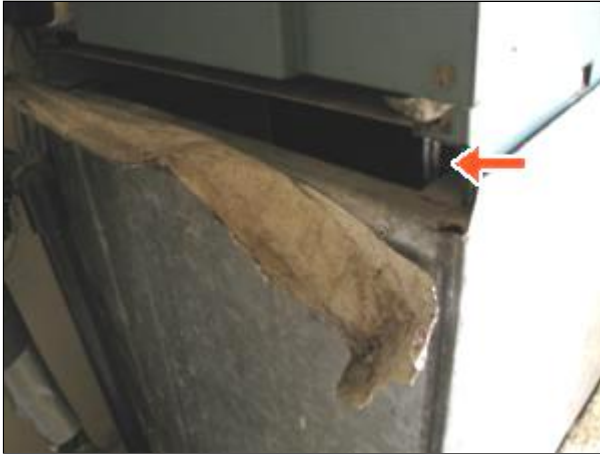
6.3 Picture 1

**6.3** (1) The washable filter is collapsed and needs replacing at upstairs. The filter needs replacing with a rigid frame to prevent filter from falling out of alignment. (Picture 1) The filter in basement (Picture 2) needs replacement and in crawlspace which is difficult to access due to the crawlspace (Picture 3). A qualified person should repair or replace as needed

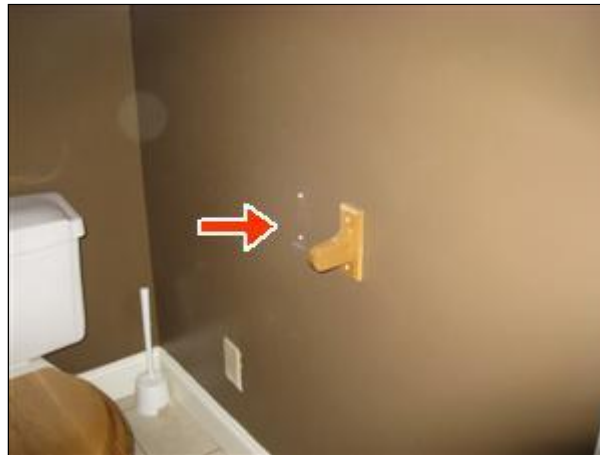
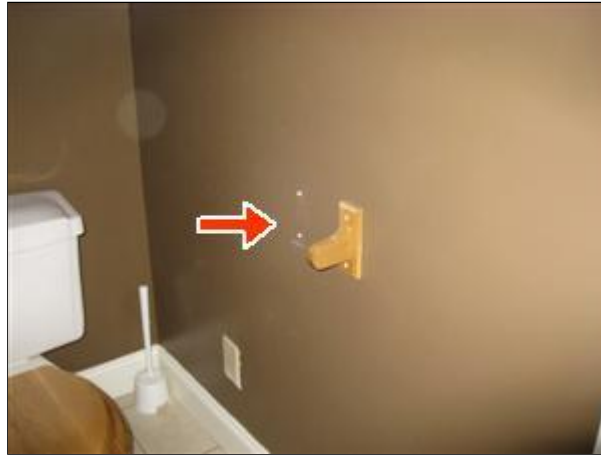
8.1 Picture 1

**8.1** The tissue holder on the wall is damaged at the master bath. I recommend repair as necessary.

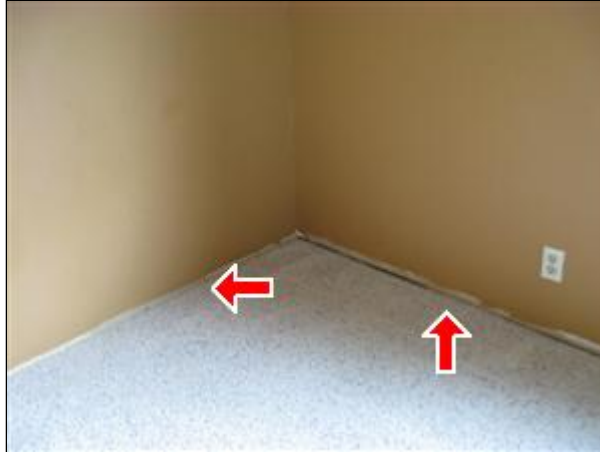
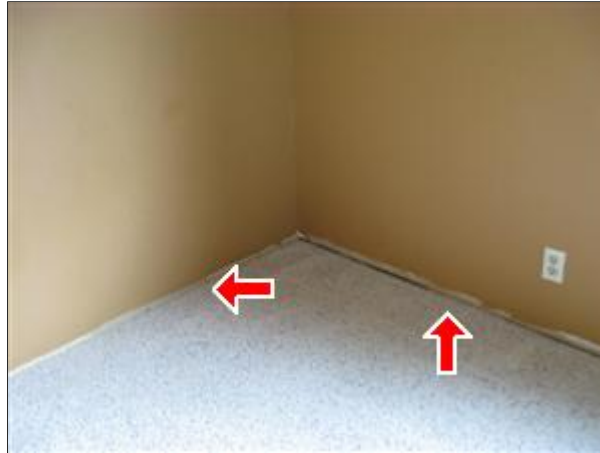
8.2 Picture 1

8.2 (1) The Baseboard is missing at the upstairs (right of hall bath). Repairs are needed. A qualified contractor should inspect and repair as needed.

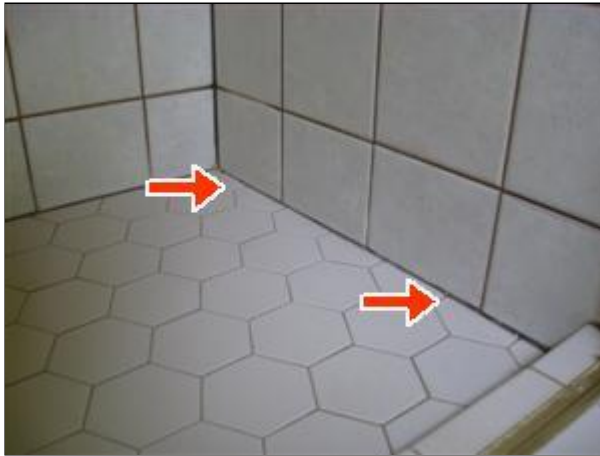
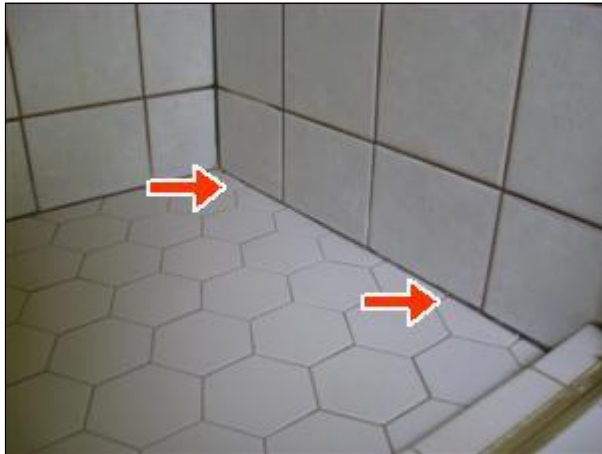
8.2 Picture 2 Upstairs bath

(2) Tile at shower pan and wall surround are loose and missing mortar or grout and sealer at the upstairs bath. Repairs are needed to prevent water damage to shower/bath. A qualified person should repair or replace as needed.

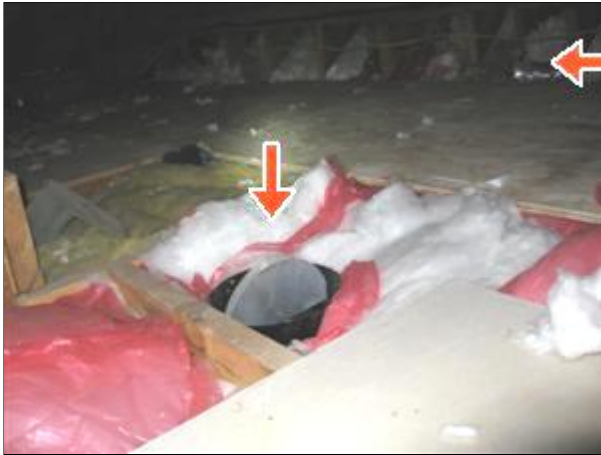
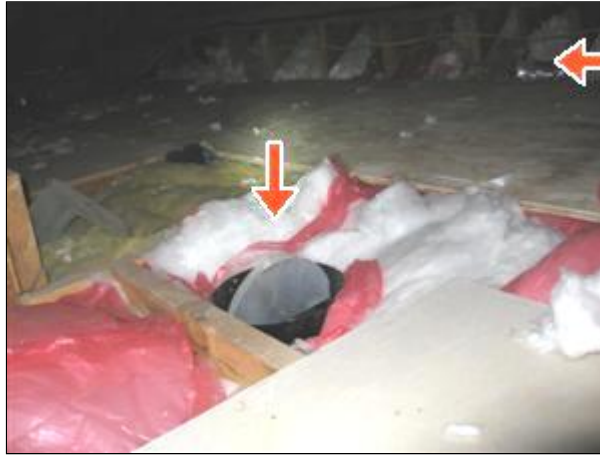
9.4 Picture 1

9.4 The Exhaust fan does not vent to outside at the hall bath and master bath. Vent pipes should terminate outside and not in the attic. Many homes have their vent pipe poised at the roof vent such as yours. It is up to you to determine whether or not this is a concern or needs further consideration from a general contractor. A qualified contractor should inspect and repair as needed.

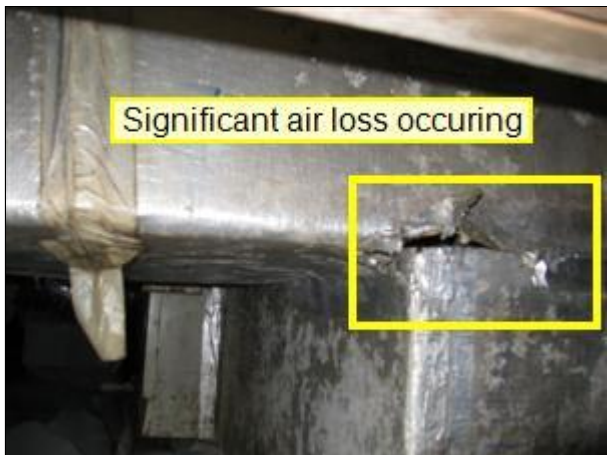
6.3 Picture 4 crawlspace new addition

🔧 (2) The supply duct pipe or main plenum is failing in the crawlspace. Energy loss is occurring in crawlspace and immediate correction is needed. A licensed HVAC contractor should service or repair unit.

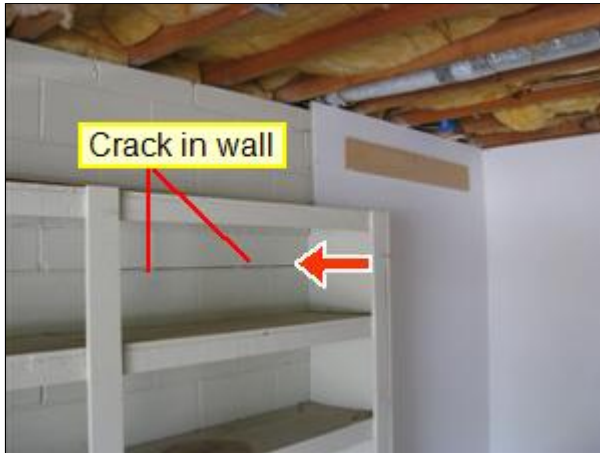
1.1 Picture 1

There is a horizontal crack(s) in the foundation wall at the left side (facing front). These cracks do not appear significant to require repairs at this time. This is my opinion and you should seek a second opinion by a qualified person.

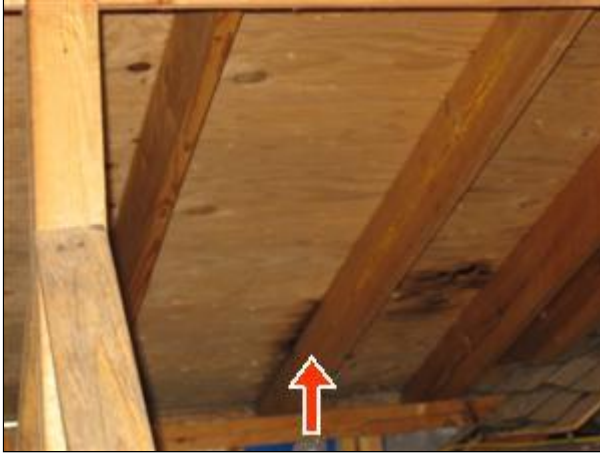
1.5 Picture 1

Leak signs in attic perhaps or likely from the *old roof* as this newer roof appears in tact. I am unable to determine if leak exists due to no recent rain.
