Inspection Report

Property Address:
333 Wild Raspberry Lane
Etowah NC

HomeBuyers Inspection HBI

Date: 12/19/2007	Time:	Report ID: Sam 1
Property: 333 Wild Raspberry Lane Etowah NC	Customer: Sample Buyer	Real Estate Professional:

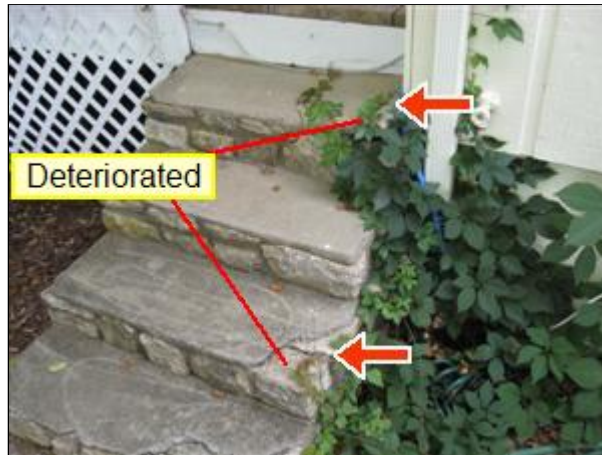
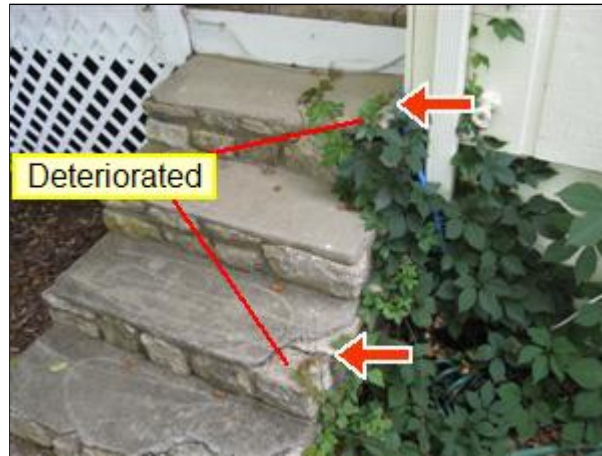
2.3 Picture 1

2.3 (1) The step tread on steps on the deck at the rear of home are deteriorated. A repair or replacement is needed. A skilled masonry contractor should perform the work.

A handrail may be needed

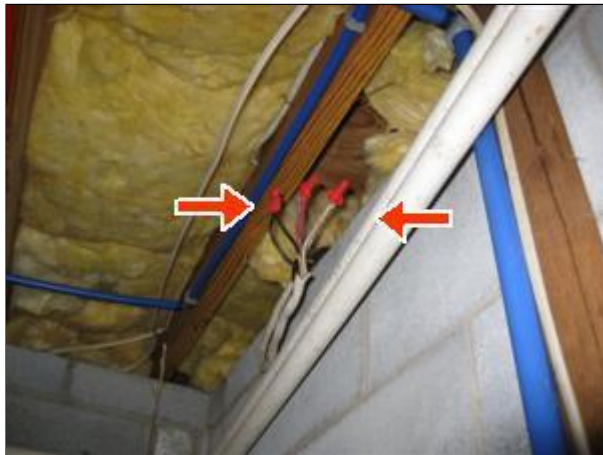
5.3 Picture 2

🔧 (2) Several loose wire ends needs placing inside a box with a cover-plate in the basement at the pressure tank of well. I recommend repair as needed.

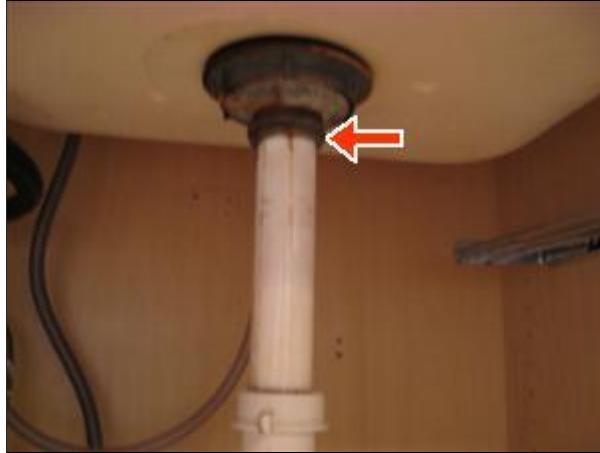
4.0 Picture 1 Right sink basin

4.0 (1) The basket strainer had leaked and corrected itself for the time being at the Kitchen sink. Repairs are needed. A qualified person should repair as necessary.

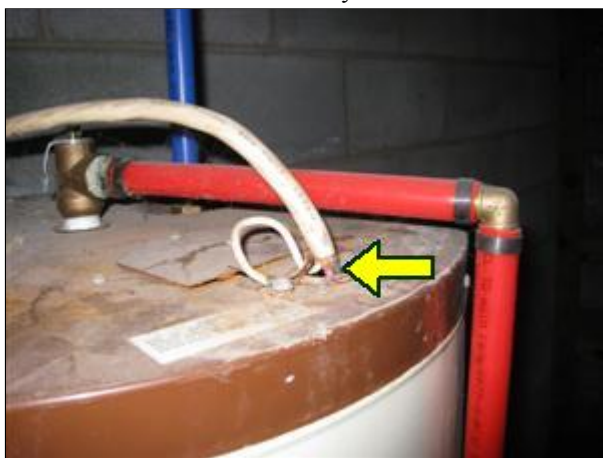
4.2 Picture 1

4.2 The wiring for the water heater missing romex connector. Electrical issues are considered a hazard until repaired. I recommend a licensed electrician correct as necessary.

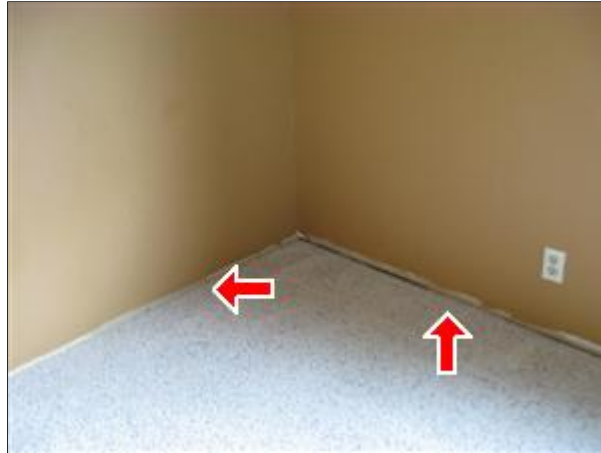
8.2 Picture 1

8.2 (1) The Baseboard is missing at the upstairs (right of hall bath). Repairs are needed. A qualified contractor should inspect and repair as needed.

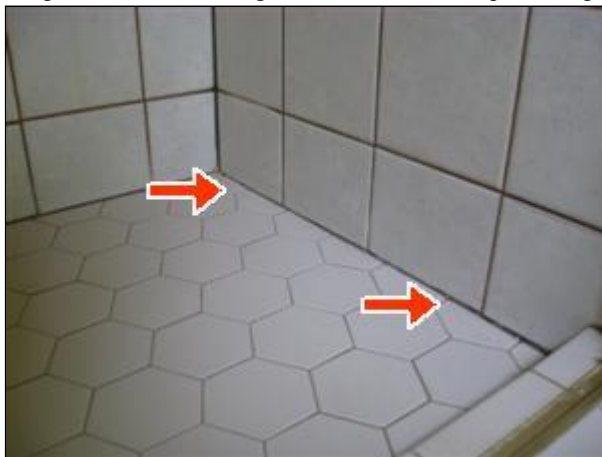
8.2 Picture 2 Upstairs bath

(2) Tile at shower pan and wall surround are loose and missing mortar or grout and sealer at the upstairs bath. Repairs are needed to prevent water damage to shower/bath. A qualified person should repair or replace as needed.

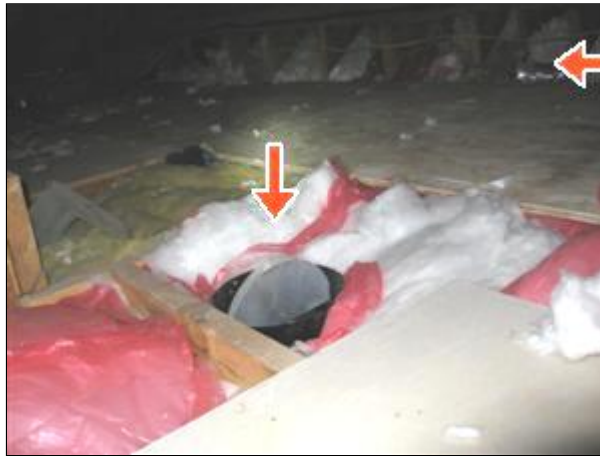
9.4 Picture 1

**9.4** The Exhaust fan does not vent to outside at the hall bath and master bath. Vent pipes should terminate outside and not in the attic. Many homes have their vent pipe poised at the roof vent such as yours. It is up to you to determine whether or not this is a concern or needs further consideration from a general contractor. A qualified contractor should inspect and repair as needed.

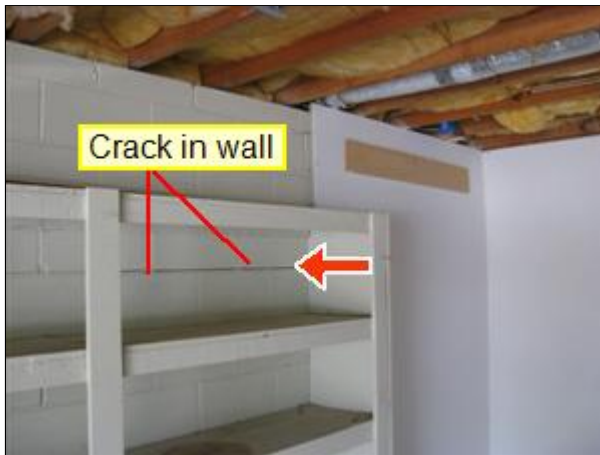
1.1 Picture 1

There is a horizontal crack(s) in the foundation wall at the left side (facing front). These cracks do not appear significant to require repairs at this time. This is my opinion and you should seek a second opinion by a qualified person.
