Inspection Report

Property Address:
333 Wild Raspberry Lane
Etowah NC

HomeBuyers Inspection HBI

Date: 12/19/2007	Time:	Report ID: Sam 1
Property: 333 Wild Raspberry Lane Etowah NC	Customer: Sample Buyer	Real Estate Professional:

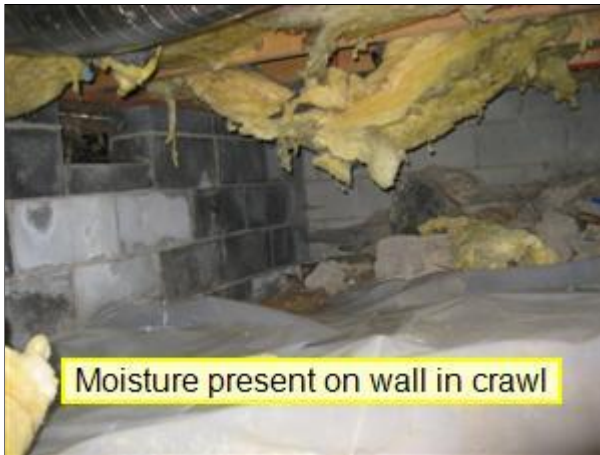
1.0 Picture 5 crawlspace under kitchen

🔍 (3) Visible signs of water intrusion in the crawspace (along front of home) are present from dampness along the block wall. I am unable to determine the extent of intrusion or how often it occurs. Cross ventilation may help as the crawls has no ventilation. I recommend further investigation or correction by a qualified licensed contractor or water infiltration specialist. Refer to the diagram as a guide if a drainage system is needed.

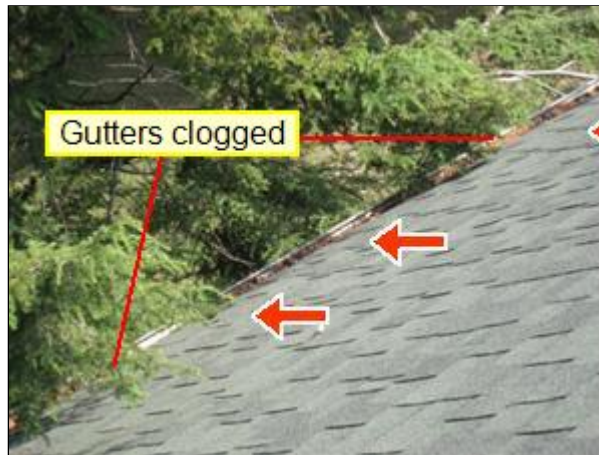
3.3 Picture 1

3.3 The gutter needs cleaning of debris at the virtually all areas where gutters are installed. Gutters that drain poorly or clogged can lead to many costly problems such as deterioration of fascia, soffit or roof edge. It can also cause gutters to pull loose and lead to possible water intrusion. A qualified person should repair or replace as needed.

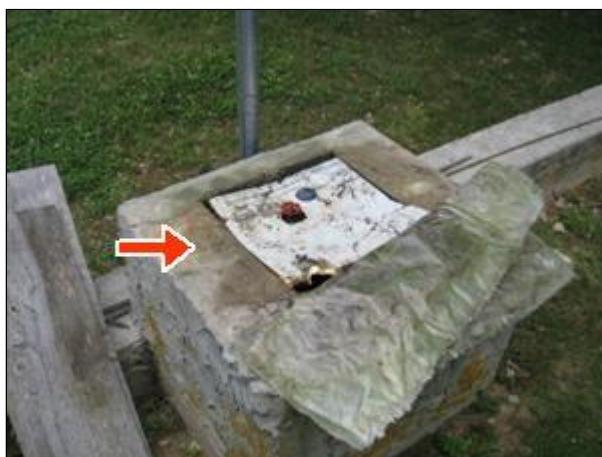
4.1 Picture 3 Well head

🔧 (3) I recommend the well head lid be insulated better before winter. FYI

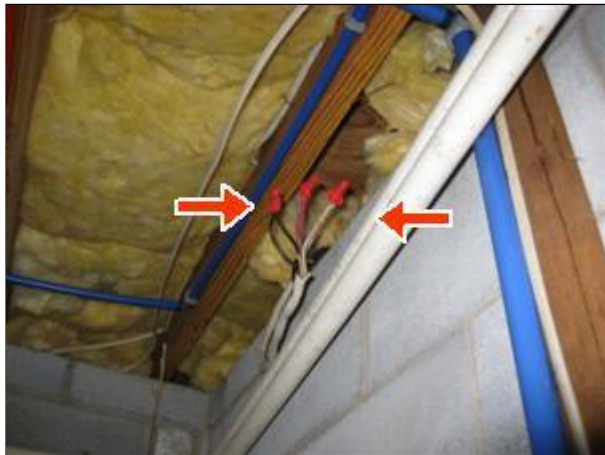
5.3 Picture 2

🔧 (2) Several loose wire ends needs placing inside a box with a cover-plate in the basement at the pressure tank of well. I recommend repair as needed.

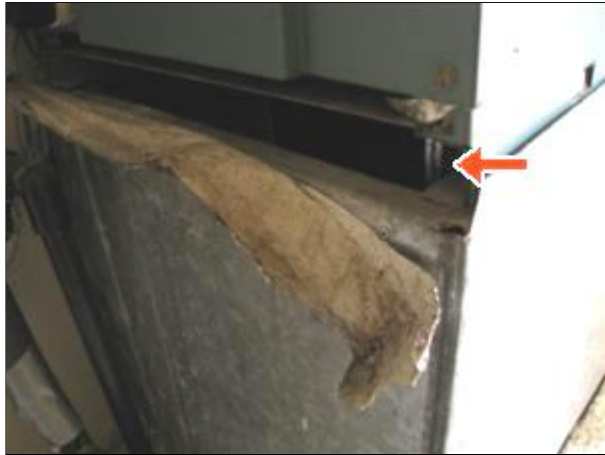
6.3 Picture 1

6.3 (1) The washable filter is collapsed and needs replacing at upstairs. The filter needs replacing with a rigid frame to prevent filter from falling out of alignment. (Picture 1) The filter in basement (Picture 2) needs replacement and in crawlspace which is difficult to access due to the crawlspace (Picture 3). A qualified person should repair or replace as needed

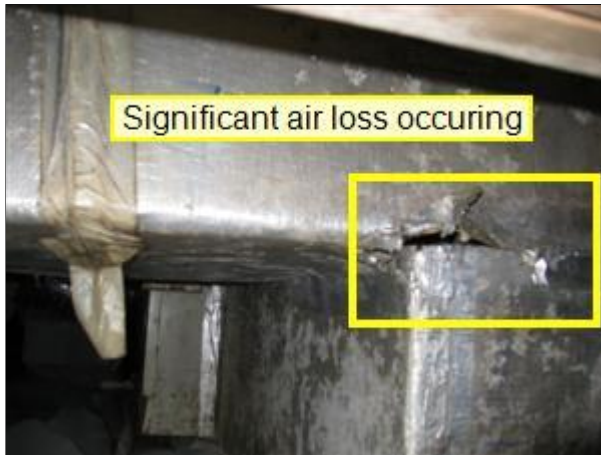
6.3 Picture 4 crawlspace new addition

🔧 (2) The supply duct pipe or main plenum is failing in the crawlspace. Energy loss is occurring in crawlspace and immediate correction is needed. A licensed HVAC contractor should service or repair unit.
